Training Graduate Students in Utilization of Analytical Instruments in a Failure Analysis Course

S. Nasrazadani, S. Sekar, N. Padamati, X. Wang, F. Gamez-Rivas

Department of Engineering Technology
University of North Texas
Denton, Texas 76207,

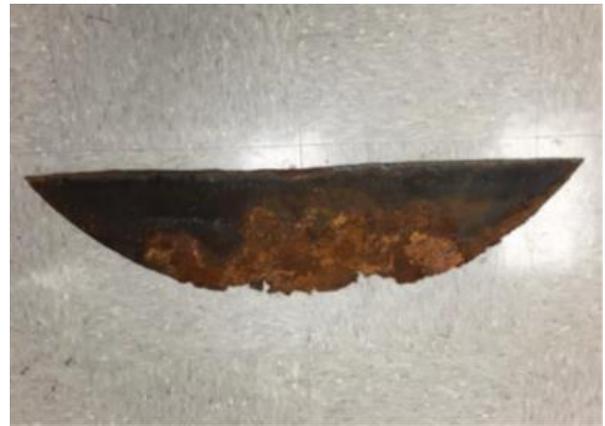
Fig. 2 Failed oil separator weir plate.

There is an extensive variety of equipment and machinery used in the oil extraction industry. When well fluids are extracted from the ground they are contaminated mixed with water and other hydrocarbon products which affect the quality of the oil. Filtration is needed to separate the oil from other contaminants and water [8]. There are multiple filtration systems in the oil industry that utilize the primary methods of gravity settling, enhanced-gravity settling, coalescing, centrifugal force and electrical charge. For liquid-gas separators, one of the most common systems is the heated horizontal separator. Heat is added to assist the separation of oil and water as well as for protection of equipment. The basic components of horizontal heated separators include an inlet diverter, mist eliminators/coaleser, relief valves, pressure regulator, level control valves, water and inlet outlets, and a weir plate [9]. Fig. 1 shows the basic components and schematic of the separator. This type of separator uses a coaleser/settler method for separation. As the contaminated oil fluid enters the separator tank it fills up the drum and the water separates to the bottom of the tank allowing the oil to layer on top of the water. A weir plate allows the lighter oil to spill into another area of the tank where the oil outlet is located. Different literatures suggest these systems can handle pressures up to 2000 psi depending on the vessel size, temperatures -20°F - 200°F and materials used for the manufacturing of the internal components are typically carbon steel [9]. The weir is a metal plate usually quarter inch thick and welded to the bottom of the tank. A failed weir plate, shown in Fig. 2, of was analyzed by a variety of methods to identify cause of failure. It can be easily observed that corrosion was the main reason for failure making this failure mode the main focus of analysis was the main form of analysis. There are other factors that could have affected or increase the rate of corrosion thus flow actuated corrosion will be discussed during the conclusion section as well. Fig. 2 shows two feet section of a severely corroded weir plate showing uniform corrosion with extensive amount of corrosion products containing iron oxide (Fe_2O_3) and oxy-hydroxides of iron ($\alpha\text{-FeOOH}$, $\gamma\text{-FeOOH}$) as identified by FTIR analysis shown in Fig. 3. Optical microstructure of the weir plate shows pearlite phase (Fig. 4.a) and SEM image showing uniform corrosion product morphology is shown in Fig. 4.b.

The extra thickness will provide extra material and make up for the corroded metal thus expanding the lifetime of the weir plate. Special coatings can be used reduce localized corrosion. New materials and coatings are arising. Fiber glass coatings have been proven effective for vessels operating at low pressure. It is important to maintain and uptake these systems.

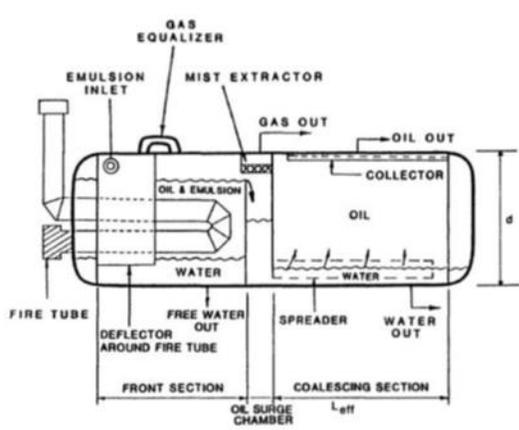
Fig. 1 Schematic of a separator system used in oil and gas

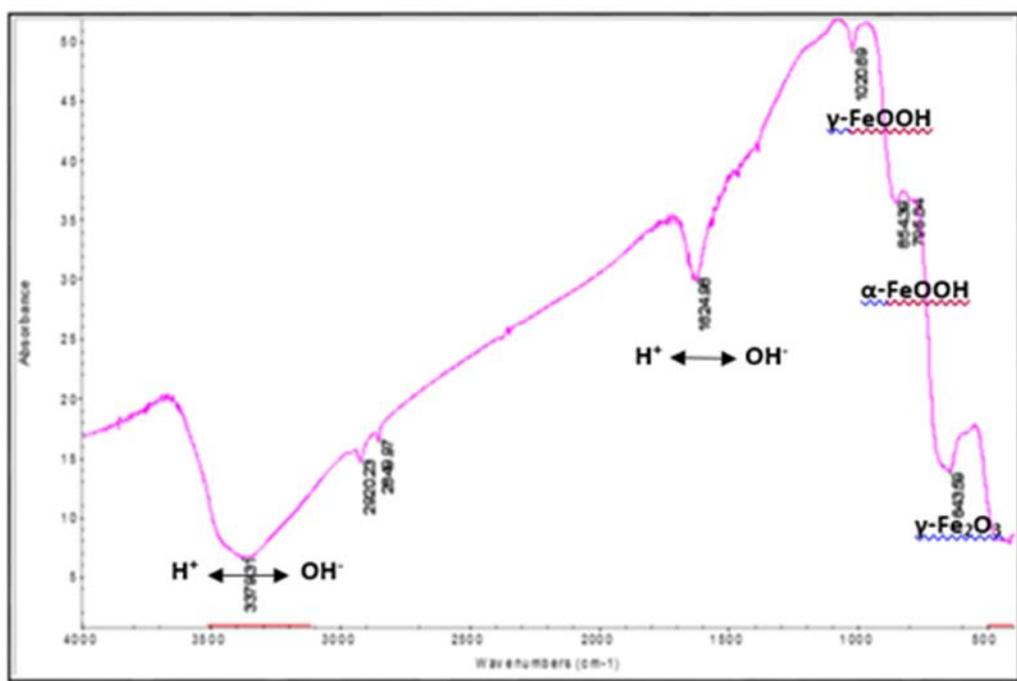
Fig. 3: FTIR spectrum of corrosion product form on the weir plate showing presence of $\gamma\text{-Fe}_2\text{O}_3$, $\alpha\text{-FeOOH}$, and $\gamma\text{-FeOOH}$ as the main rust constituents.

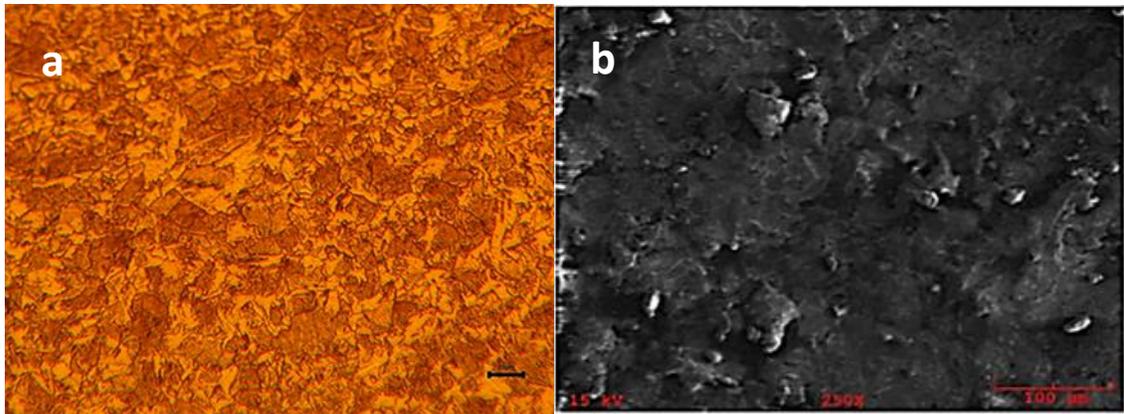
Fig. 4 Optical micrograph (a) and SEM micrograph (b) of a severely corroded weir plate from an operational oil exploration

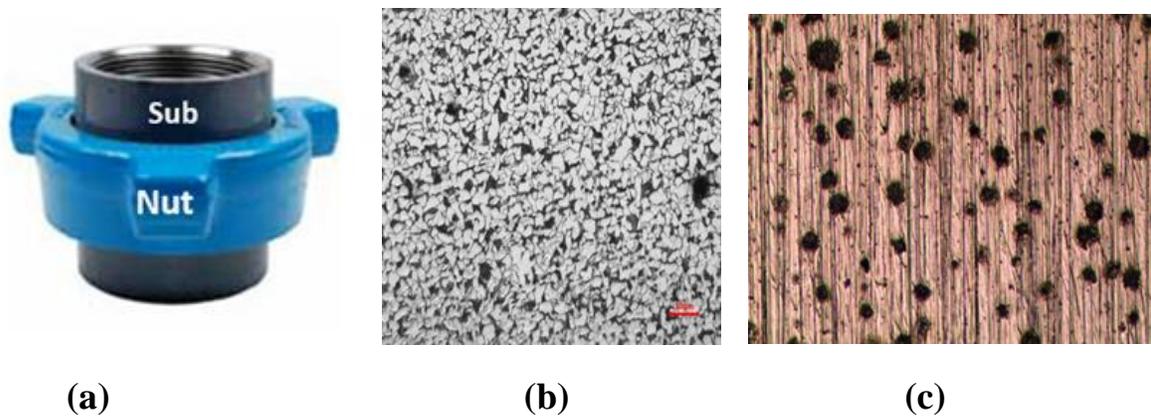
Hammer union system include a sub and a nut as shown in Fig. 5 (a). Sub is made of low carbon steel with microstructure containing pearlite (Fig. 5.b) and the nut is nodular cast iron (Fig. 5.c). Corrosion of Hammer union (external, internal, or atmospheric) will depend on the environment and the changes that occur during the life of that Hammer union. The material used in the design of this component include

Fig. 5: Hammer union system (a), microstructure of the sub showing pearlite phase (b), and microstructure of the nut showing nodules in nodular cast iron (c).

A group of two students worked on the Hammer union system corrosion and utilized SEM and optical microscopes to observe morphological features of the corrosion mechanism and characterized corrosion products using FTIR and EDS. Their findings showed uniform corrosion as the main form of corrosion along with possibility of erosion corrosion due to high velocity corrosive agents flow. Through this project students reviewed advantages and disadvantages of engineering alloys such as cast iron and low carbon steel.

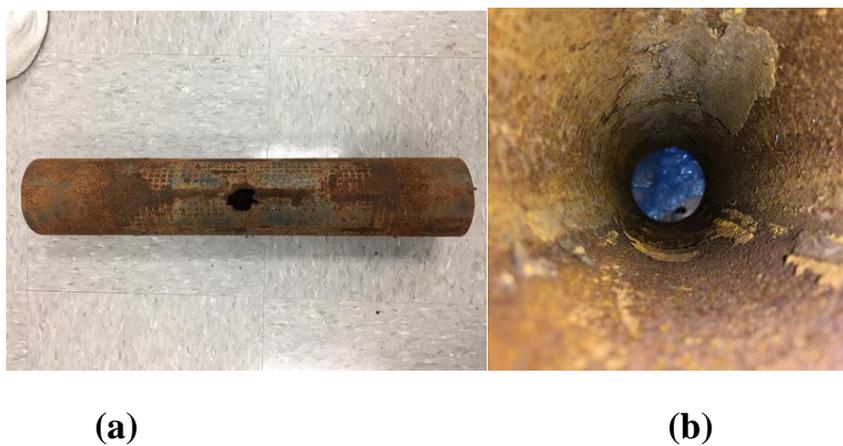
The operating conditions for the pipe segment are: pressure is less than 15 psi, fluid velocity is 300 BBL/Day which is low, fluid temperature is between 150°F (65.5°C). Also, the sample may be subjected to bacterial attack. As indicated in external part of the pipe in Figure 6 a, the pipe has been covered with an insulation or wrapped with a cover where large perforation was detected. Interior part of the part shows uniform corrosion. Usually when there is a highly localized failure such as the one shown in Fig. 6.a one possibility is stray form of corrosion due to unintended anode to cathode connection in underground piping system. In this case, since the pipe was used above ground the bacteria attack may have been the culprit for the failure. Generally bacteria and other microorganisms accumulate in a highly localized regions increasing acidity of the location by decreasing the pH. Low pH electrolytes severely attacks the alloy resulting in speedy dissolution of the metal leading to formation of large perforations such as the one shown in Fig. 6.a. Fig. 6.b shows accumulations of corrosion products and other precipitates from the moving corrosive fluids.

Fig. 6: External part of a API-5L Grade B low carbon steel pipe (a) and corresponding internal image (b).
